EXPANDED
SCREENING SITE INSPECTION REPORT

TREASURE ISLAND-MANHATTAN DUMP
2020 Manhattan Boulevard
Toledo, Ohio 43612

U.S. EPA ID NO.: OHD 980 611 305

EPA Work Assignment No.	:	29-5JZZ
EPA Region	:	5
Date Prepared	:	September 14, 1993
Contract No.	:	68-W8-0084
PRC No.	:	030-002968
Prepared by	:	PRC Environmental Management, Inc. (Kristine Kruk)
Contractor Project Manager	:	Julie Kaiser
Telephone No.	:	(312) 856-8700
EPA Work Assignment Manager	:	Jeanne Griffin
Telephone No.	:	(312) 886-3007

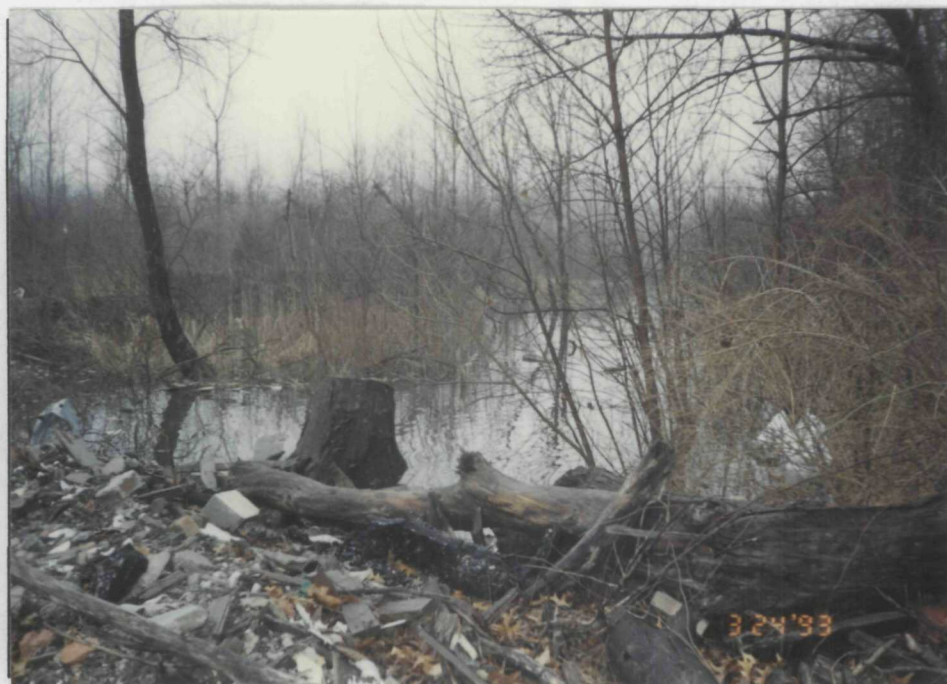
Sample No. SW-02 was collected along the southern bank of the storm sewer drainage ditch about 200 feet downgradient of Sample No. SW-01 (see Photograph No. 1). Sample No. SW-02D was collected as a duplicate for Sample No. SW-02. Sample No. SW-03 was collected on the western bank of the northeastern pond. An OEPA on-site investigation states that leachate was observed seeping in the pond in this area. Sample No. SW-04 was collected from a potential wetland on the eastern bank of the sewer drainage ditch near the western border of the former Tuber Dump (see Photograph No. 4). Cattails were observed about 8 feet north of the location from which Sample No. SW-04 was collected.

stainless steel scoops, spoons, and bowls. Sample No. SD-01 is a background sample collected along the south bank of the storm sewer ditch about 15 feet southeast of the storm sewer outfall (see Photograph No. 3). This sample was collected to determine concentrations of contaminants attributable to off-site storm water runoff. Sample No. SD-02 was collected along the southern bank of the storm sewer drainage ditch about 200 feet downgradient of where Sample No. SD-01 was collected (see Photograph No. 1). Sample No. SD-02D was collected as a duplicate for Sample No. SD-02. Sample No. SD-03 was collected on the western bank of the northeastern pond. An OEPA on-site investigation states that leachate was observed seeping in the pond in this area. Sample SD-04 was collected from a potential wetland on the eastern bank of the sewer drainage ditch near the western border of the former Tuber Dump (see Photograph No. 4). Cattails were observed about 8 feet north of the Sample No. SD-04 sampling location.

Photograph No. 4
 Orientation: North
 Description: Sampling a wetland; note cattails about 8 feet north of the sampling location; sampling location near northwest portion of the former S.H. Tuber Company (Tuber) Dump

Sampling Location: SD-04 and SW-04
 Date: 03/23/93

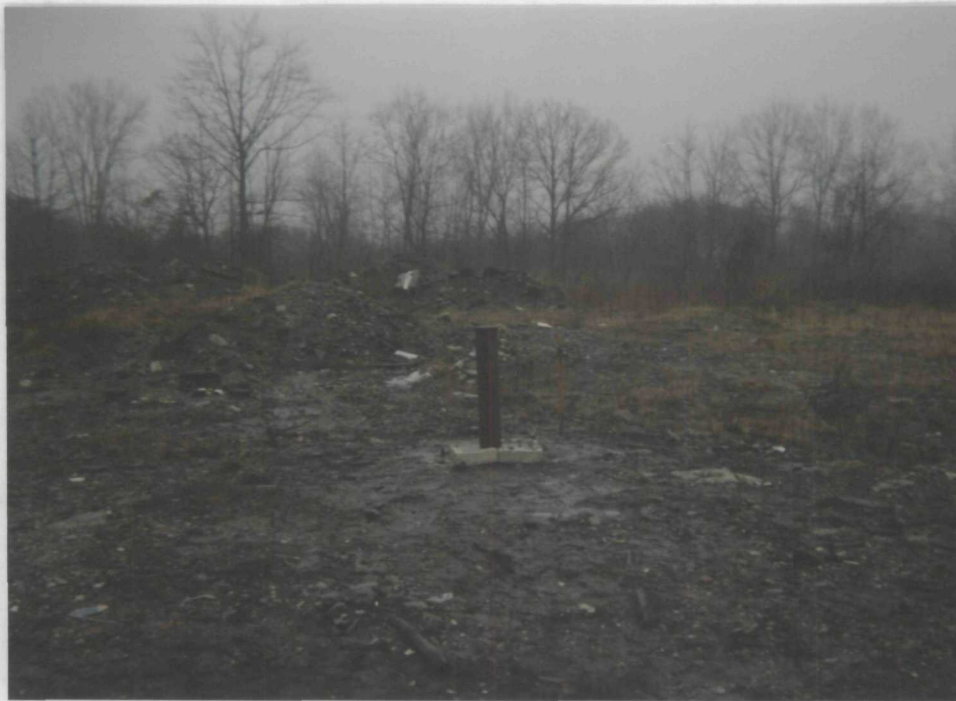
Sampling Location: SD-05

Date: 03/24/93
